Preliminary Report

**Accident involving Air India's B787-8 aircraft bearing registration VT-ANB
at Ahmedabad on 12 June 2025**

**Government of India
Ministry of Civil Aviation
Aircraft Accident Investigation Bureau**

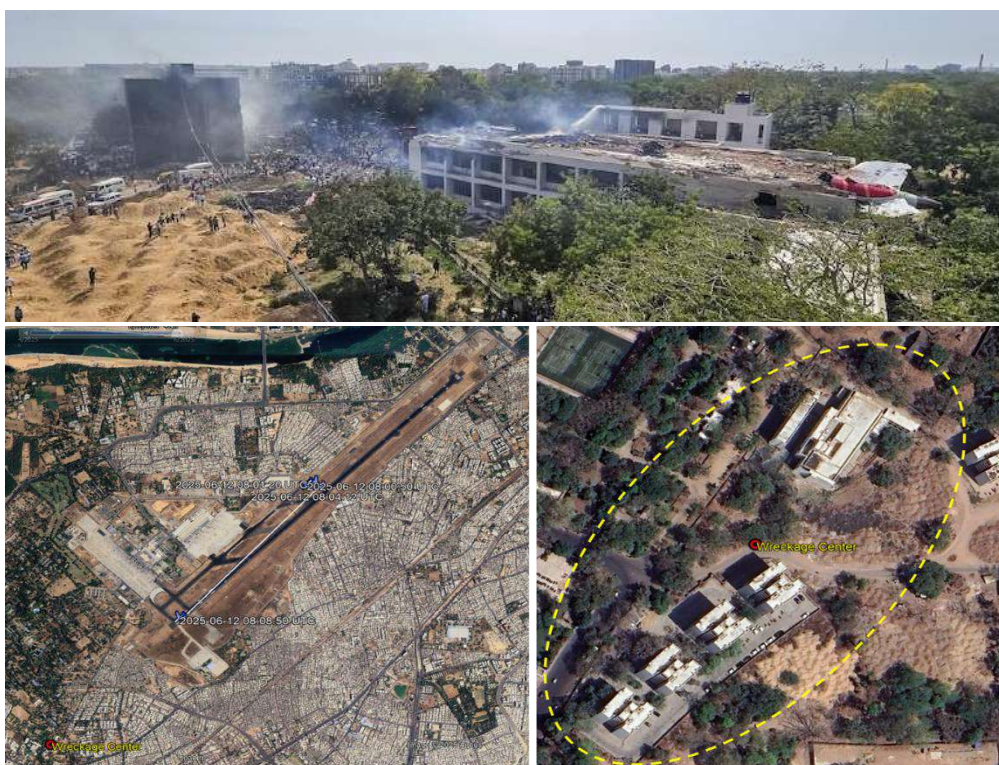
Figure 1 Accident Site with respect to airport (left) and debris field

The Aircraft was destroyed due to impact with the buildings on the ground and subsequent fire. A total of five buildings shown in the figure below were impacted and suffered major structural and fire damages.

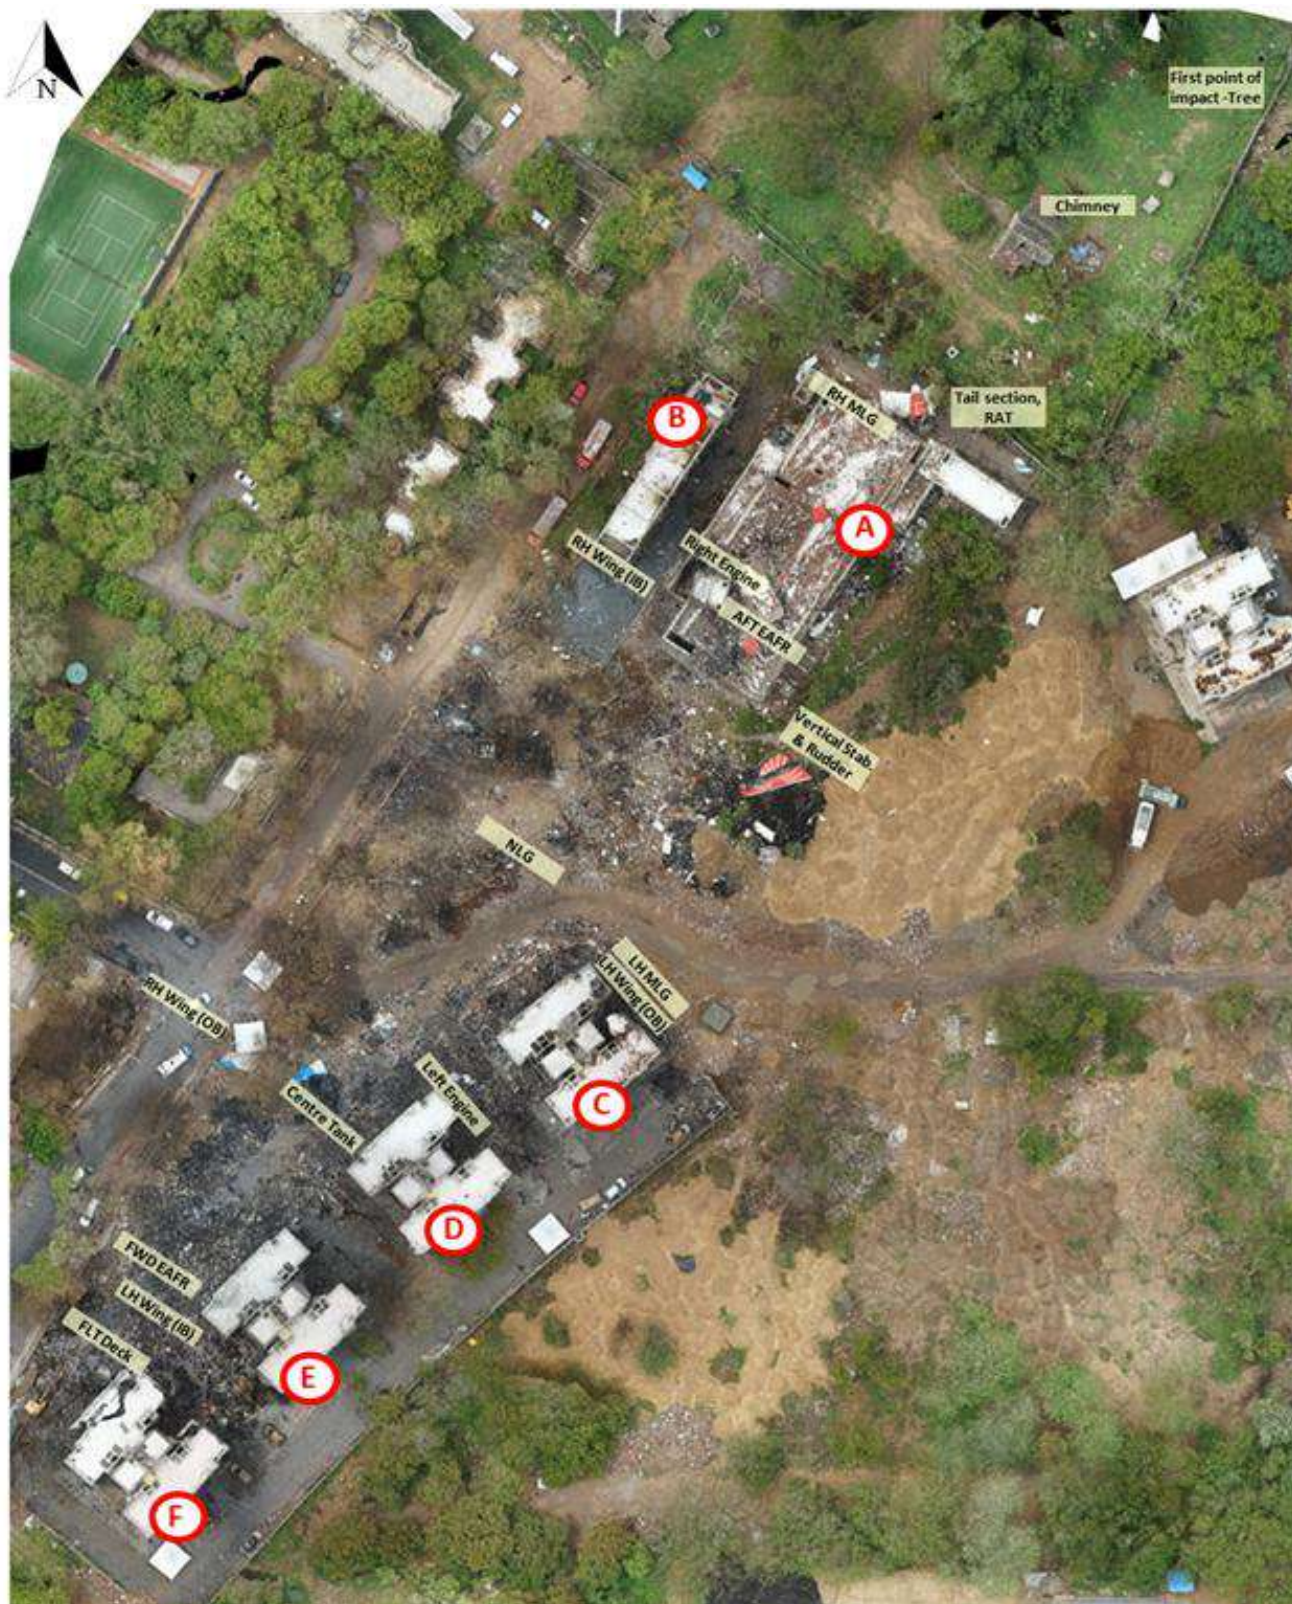
Figure 2 Wreckage layout

After takeoff, the aircraft impacted the BJ Medical College hostel which is 0.9 NM from the departure end of Runway 23. The Emergency Locator Transmitter (ELT) was not activated during this event. The wreckage, from the first impact point till the last identified aircraft item, was distributed in an area of approx. 1000 ft * 400 ft. A layout of the crash site has been given in Fig. 2 indicating the significant parts of the aircraft. The buildings at the wreckage site have been labelled alphabetically from A-F in the layout for easy reference.

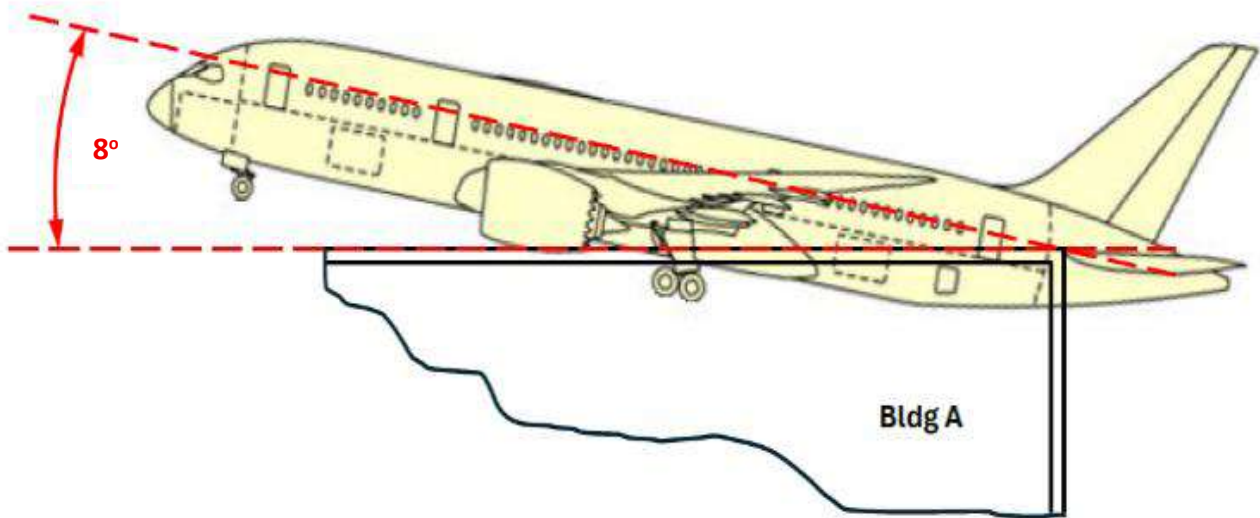
Figure 3 Aircraft attitude at the time of impact with Building A

As the aircraft was losing altitude, it initially made contact with a series of trees and an incineration chimney inside the Army Medical Corps compound before impacting the northeast wall of the Building A. The distance between the tree on which the aircraft made its initial contact and the point on the Building A where the aircraft impacted is 293 ft. As the

aircraft moved forward, it continued fragmenting and collided with other structures and vegetation. The impact witness marks on the building and airplane indicated a likely nose-up attitude (about 8°) and wings level.

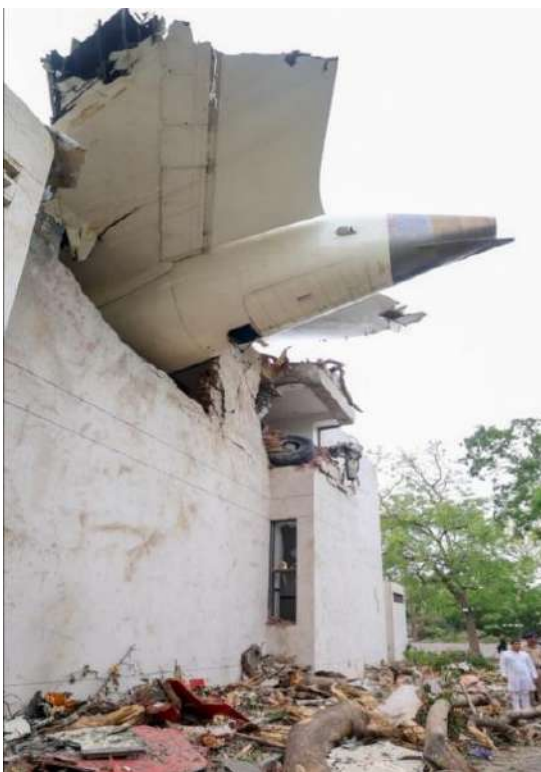
Figure 4 Tail section & RH MLG embedded in the building A

The vertical stabilizer (*fig. 5*) separated from the aft fuselage and came to rest about 200 feet south of the initial point of contact with the Building A. The tail section and the RH Main Landing Gear (MLG) of the aircraft were found embedded in the northeast wall of the Building A while the rest of the airplane continued its forward movement.

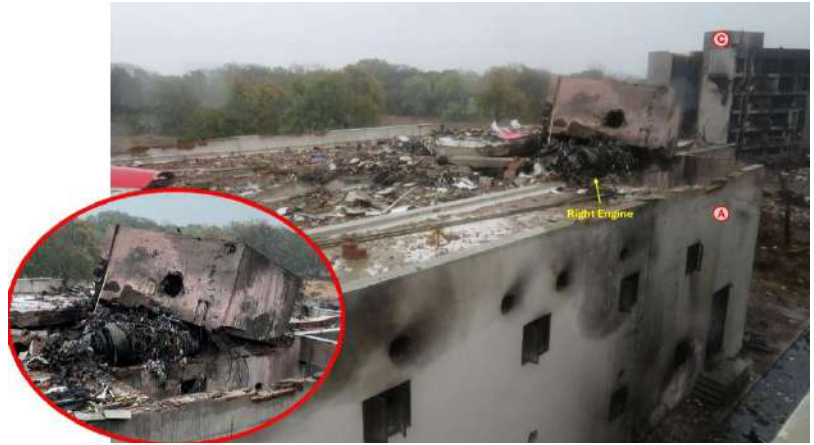
Figure 6 RH Engine

As the airplane continued its path across the roof of the Building A the right engine (*fig. 6*) struck the concrete water tank structure, separated from the airplane and rested underneath the water tank structure facing a heading of approx. 226 degrees near south-west wall of the Building A.

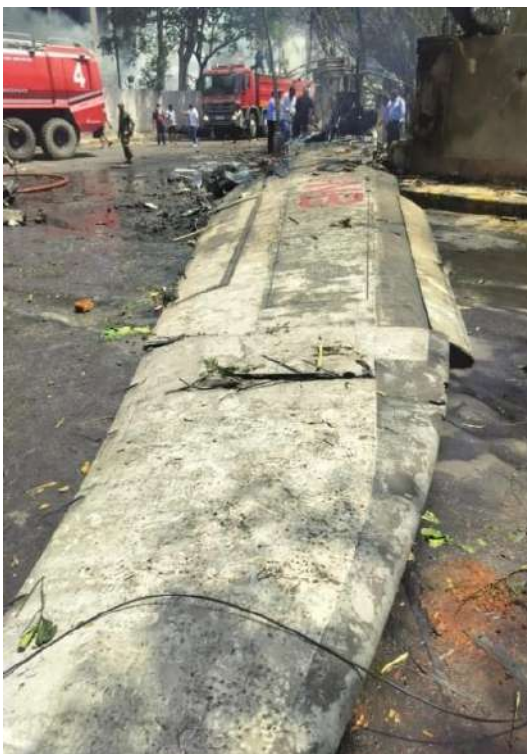
Figure 7 : RH Wing Outboard

The right-wing mid-section and the outboard section (*fig.7*) was about 280 feet and 520 feet southwest respectively from the initial point of contact with the Building A.

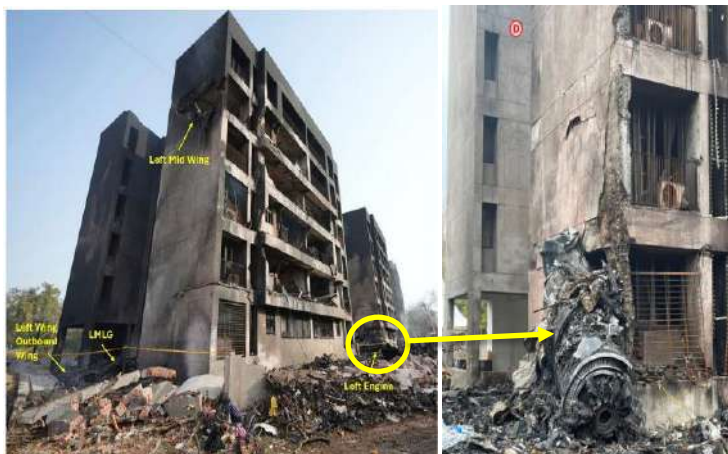
Figure 8 LH Engine

The left engine (*fig.8*) got separated from the airplane and struck the north corner of Building D at the ground level where it remained and was roughly perpendicular to the right engine resting position, at heading of approx. 326 degrees. The wall was pushed into the

building and the northwest building column was damaged such that portions of the concrete

were missing and exposing the internal metal rebar. The engine, remaining portions of attached cowling, and the surrounding area were heavily damaged by fire.

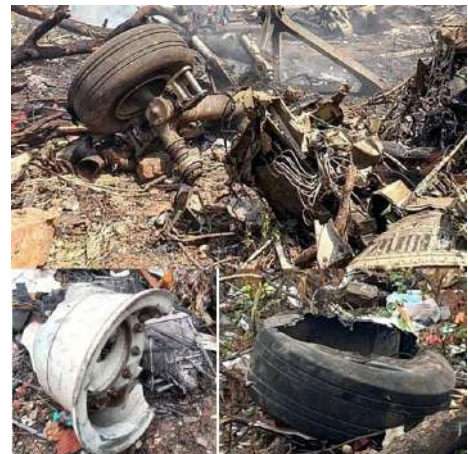
Figure 9 Nose Landing Gear

The nose landing gear (NLG) (*fig. 9*) was found on the ground about 307 feet southwest from the initial point of contact with Building A.

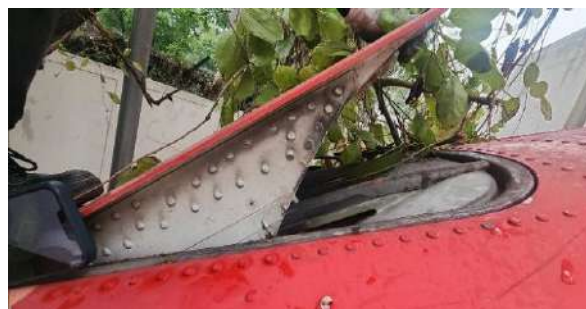
Figure 10 APU Air Inlet Door

After the tail section was brought down, the APU was inspected and found intact inside the APU compartment. The APU air inlet door (*fig. 10*), which was intact, was found open.

As per the EAFR, the Engine 1 fuel cutoff switch transitioned from CUTOFF to RUN at about 08:08:52 UTC. The APU Inlet Door began opening at about 08:08:54 UTC, consistent with the APU Auto Start logic. Thereafter at 08:08:56 UTC the Engine 2 fuel cutoff switch also transitions from CUTOFF to RUN. When fuel control switches are moved from CUTOFF to RUN while the aircraft is inflight, each engines full authority dual engine control (FADEC) automatically manages a relight and thrust recovery sequence of ignition and fuel introduction.

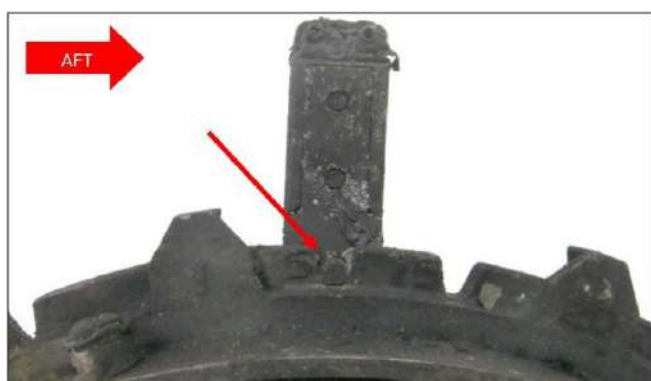
Figure 11 Flap Handle Lever

The flap handle assembly (*fig.11*) sustained significant thermal damage. The handle was found to be firmly seated in the 5-degree flap position, consistent with a normal takeoff flap setting. The position was also confirmed from the EAFR data. The landing gear lever was in “DOWN” position. (*fig.12*)

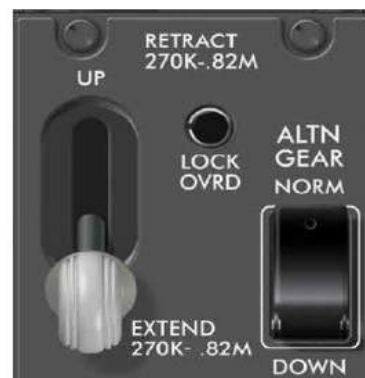
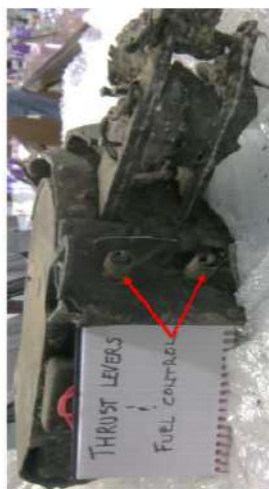
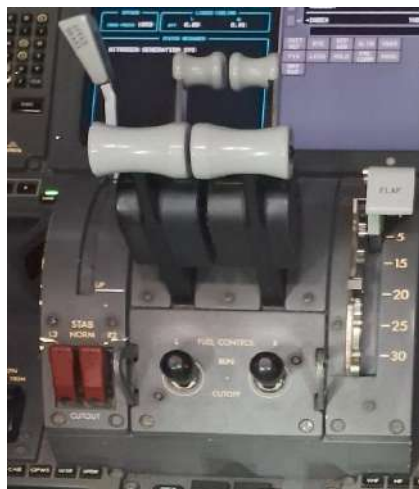
Figure 13 Thrust Lever Quadrant & Fuel Control Switch

The thrust lever quadrant sustained significant thermal damage. Both thrust levers were found near the aft (idle) position. However, the EAFR data revealed that the thrust levers remained forward (takeoff thrust) until the impact. Both fuel control switch were found in the “RUN” position. (*fig.13*) The reverser levers were bent but were in the “stowed” position. The wiring from the TO/GA switches and autothrottle disconnect switches were visible, but heavily damaged.

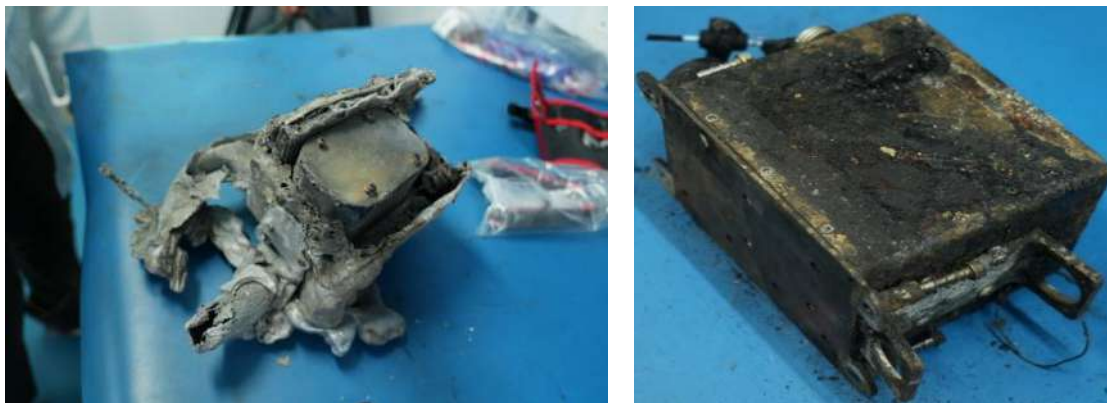
Figure 14 EAFR AFT & FWD

The aft EAFR was located on the roof top of Building A on 13th June 2025. The EAFR had impact and thermal damages to the housing. The wires were protruding from the housing and the connectors were burnt.

The forward EAFR was located on 16th June 2025 from the wreckage debris besides the Building F. The EAFR was burnt and covered in soot. The EAFR was still attached to the

equipment shelf with part of the connector melted but still connected. The ULB was still connected to the housing and the lithium battery was also attached to the equipment shelf, which was removed later prior to transportation.

The aft EAFR was substantially damaged and could not be downloaded through conventional means. The CPM was opened to inspect the memory card. The damage was extensive.

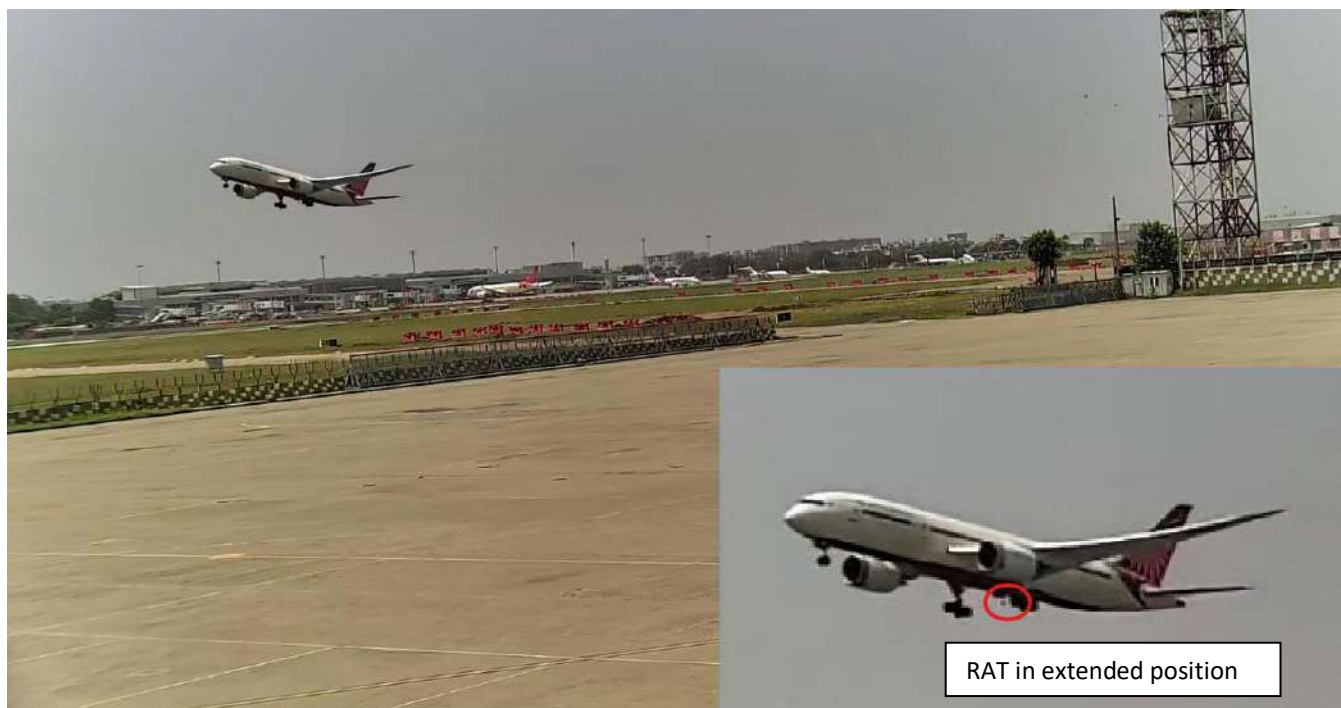
Figure 15 CCTV screenshot of RAT Deployment

The CCTV footage obtained from the airport showed Ram Air Turbine (RAT) getting deployed during the initial climb immediately after lift-off (*fig. 15*). No significant bird activity is observed in the vicinity of the flight path. The aircraft started to lose altitude before crossing the airport perimeter wall.
